# **BATTLESHIP TEXAS (BB-35)**

## **VESSEL INSPECTION AND ASSESSMENT**

Vessel Survey Report No. 2417

Vessel surveyed at:	La Porte, Texas
Dates of survey:	November - December 2010 January 2011
Vessel surveyed:	Battleship TEXAS (BB-35)
Survey commissioned by:	Texas Parks & Wildlife Battleship TEXAS State Historic Site 3523 Independence Parkway South La Porte, Texas 77571
Purpose of survey:	Vessel Condition Survey

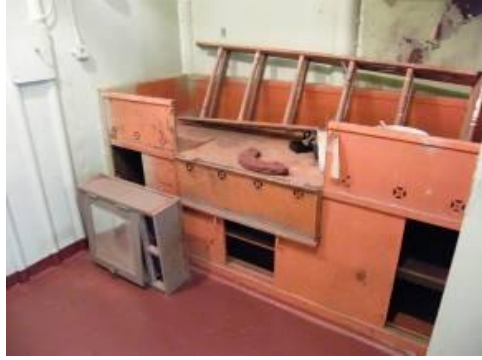
**Figure 122 Stateroom “R” (Port)**

This space (Figure 122) is in good structural and cosmetic condition.

<b>Prepare, prime and paint space.</b>
--

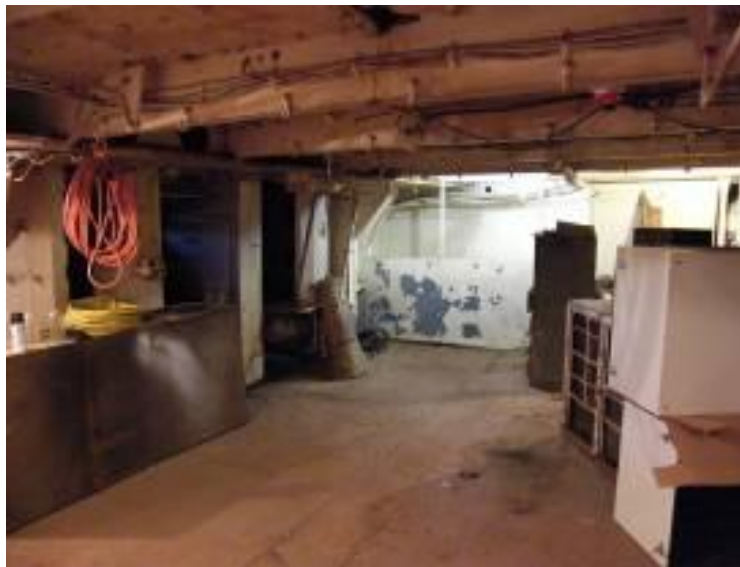
**Figure 128 Crew Space (Casemate No. 4; Port)**

This space (Figure 128) is in good structural and cosmetic condition.

<p><b>Prepare, prime and paint space.</b></p>
---

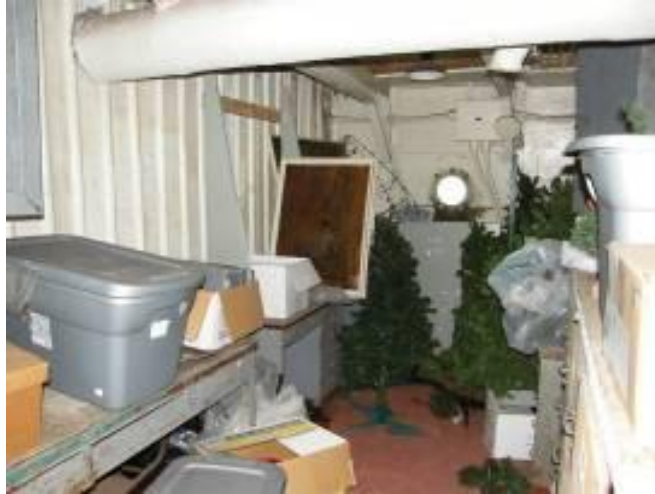
**Figure 134 Engineer's Office (Port)**

This space (Figure 134) , utilized for storage, is in good structural and good cosmetic condition.

**Prepare, prime and paint space.**

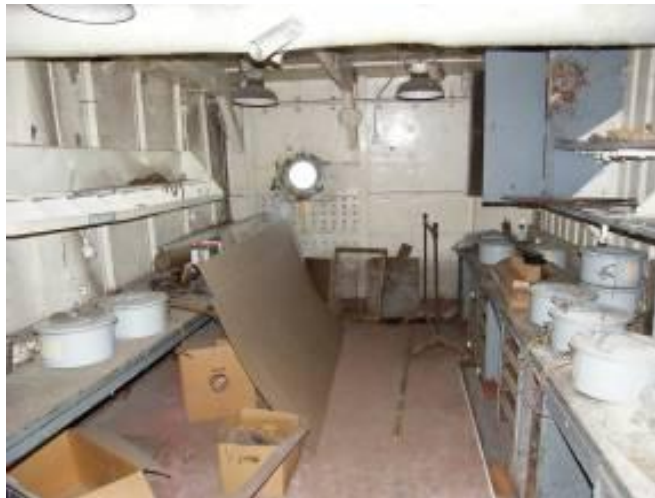
**Figure 135 GSK Office (Port)**

This space (Figure 135), utilized for storage, in good structural and good cosmetic condition.

**Prepare, prime and paint space.**

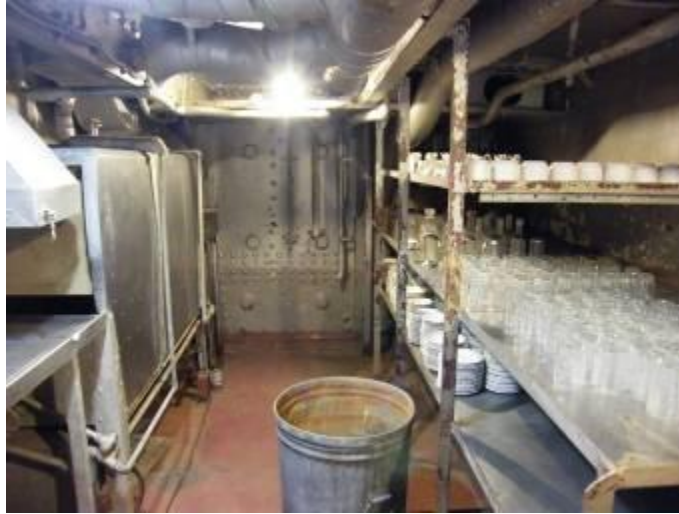
**Figure 139 Scullery (Starboard)**

This structure (Figure 139) is in good structural and good cosmetic condition.

<b>Prepare, prime and paint space.</b>
--

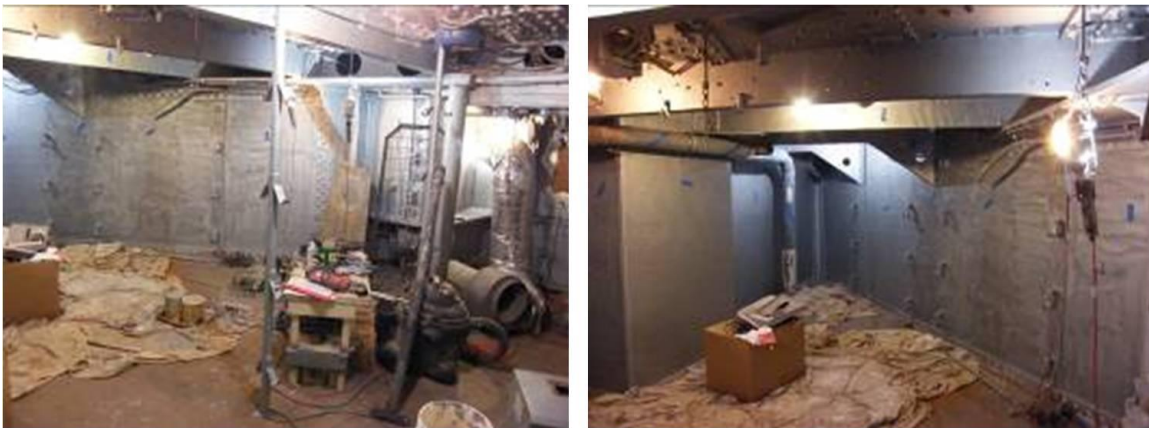
**Figure 140 Crew Space (Casemate No. 1; Starboard)**

This space (Figure 140) is being currently restored, and is in good structural and cosmetic condition.

<b>Prepare, prime and paint space.</b>
--

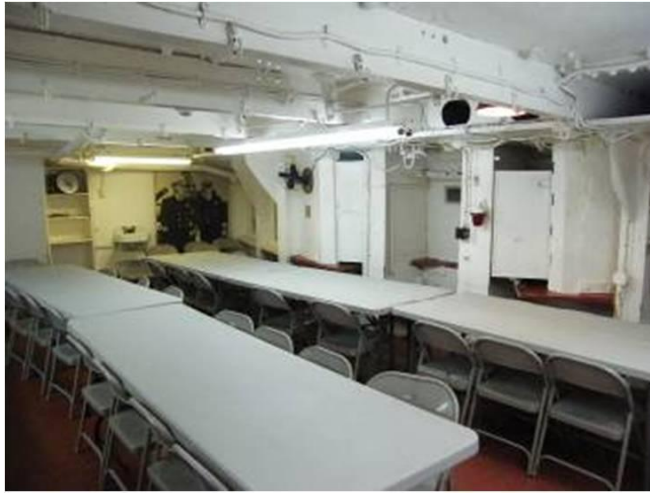
**Figure 141 Crew Space (Casemate No. 3)**

This space is in good structural and good cosmetic condition.

<b>Prepare, prime and paint space.</b>
--

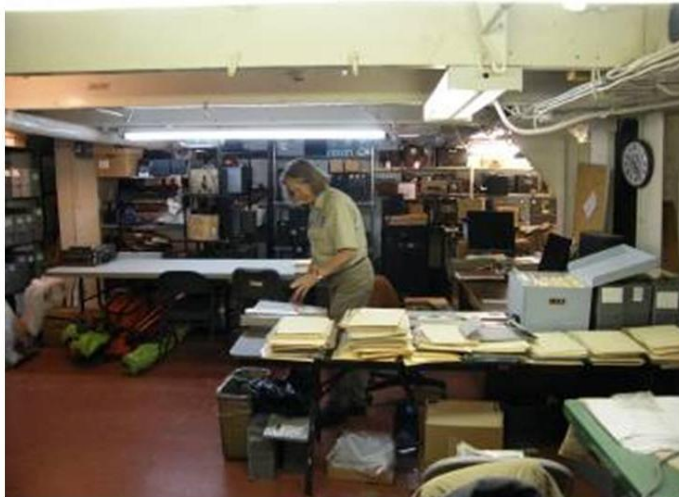
**Figure 142 Crew Space (Casemate No. 5, Curatorial Office; Starboard)**

This space (Figure 142) is in good structural and good cosmetic condition.

<b>Prepare, prime and paint space.</b>
--

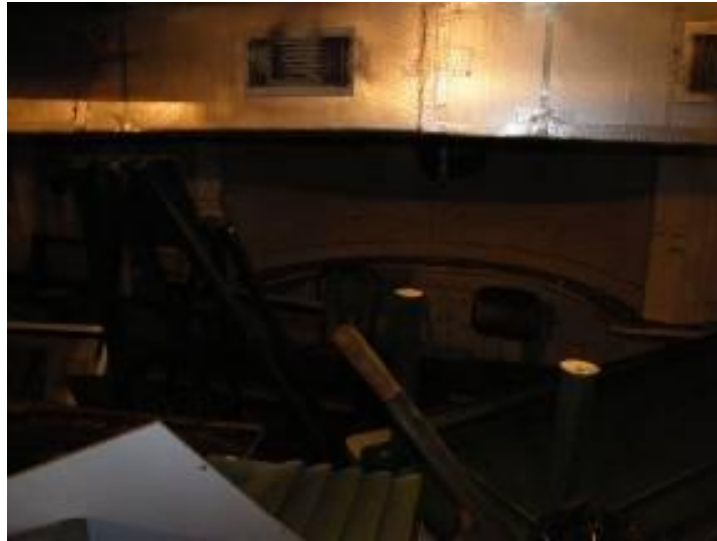
**Figure 143 Crew Space (Casemate No. 7, Storeroom; Starboard)**

This space (Figure 143) is in good structural and poor/fair cosmetic condition. Much debris in this

space could be removed.

**Prepare, prime and paint space.**

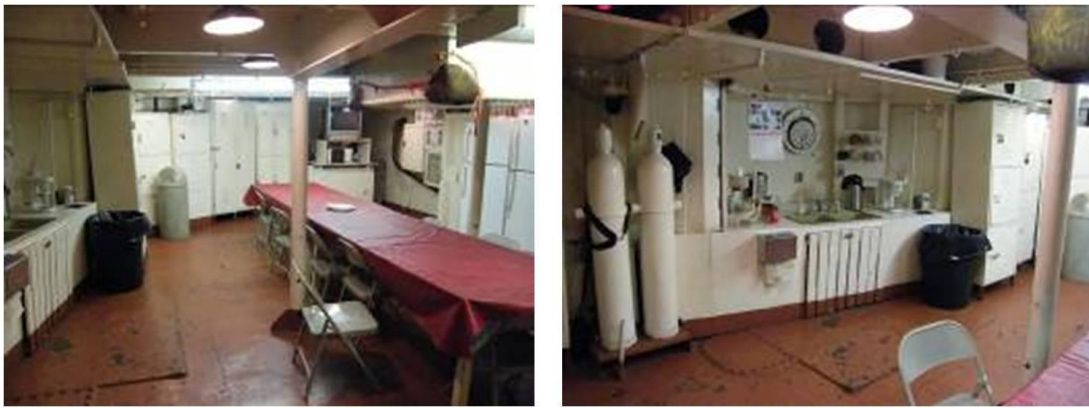
**Figure 144 Crew Space (Casemate No. 9, Lunch Room; Starboard)**

This space (Figure 144) is in good structural and good cosmetic condition.

**Prepare, prime and paint space.**

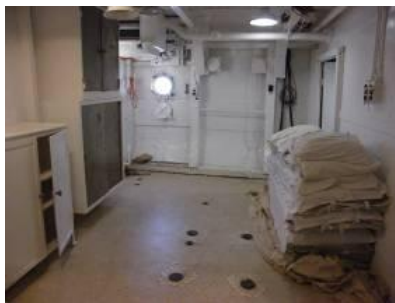
**Figure 150 Operating Room (Starboard)**

This space (Figure 150) is in a phase of restoration with repair of broken tile needed, and painting.

**Repair broken tile.**

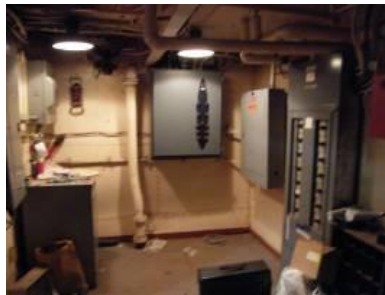
**Figure 155 Administrative Office**

This space (Figure 155) is in good structural and poor/fair cosmetic condition; much of the debris could be removed.

**Prepare, prime and paint space.**

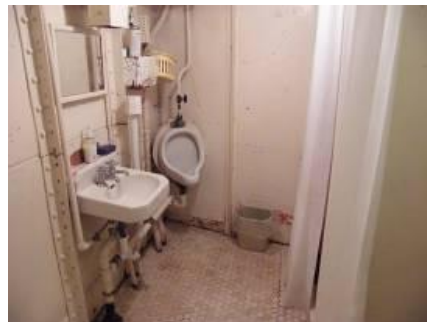
**Figure 156 Wardroom W.C**

This space (Figure 156) is in good structural and poor/fair cosmetic condition; much of the debris could be removed.

**Prepare, prime and paint space.**

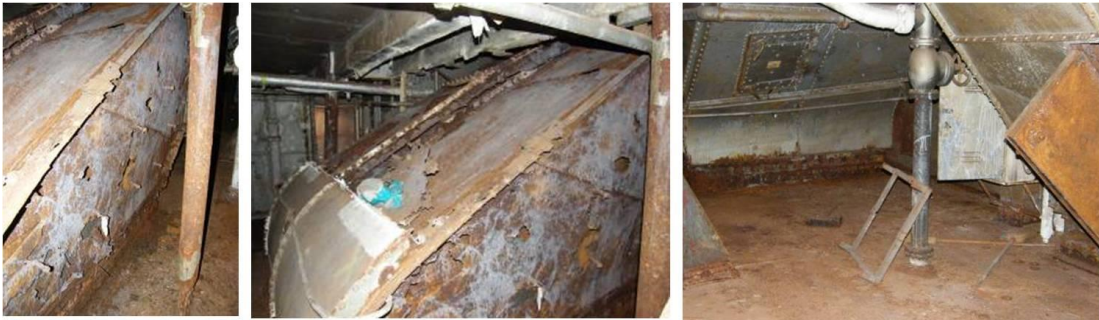
**Figure 157 Drying Room**

In this space (Figure 157), there is much corrosion on uptakes, decks and bulkheads with heavy wastage on uptake covers. The deck is thin in areas, but is not a serious cause for concern at this time.

**Consider restoration of uptake covers if desirable. Prepare, prime and paint entire space.**

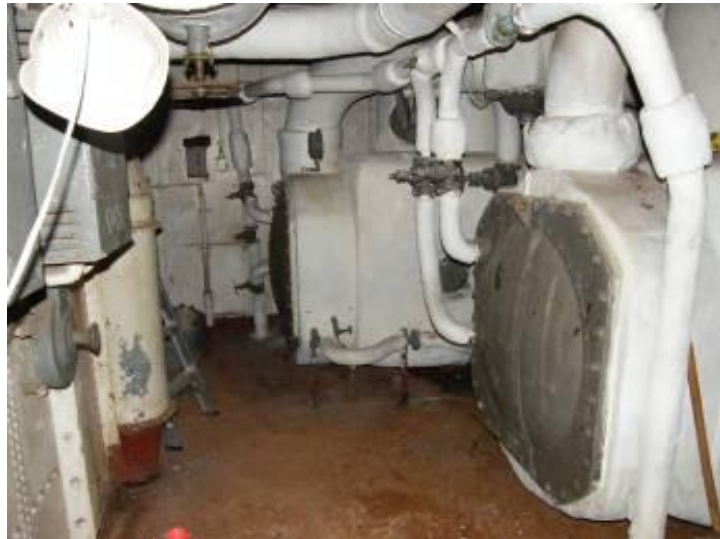
**Figure 162 Evaporator Room**

This space (Figure 162) is in original condition and is not opened on a regular basis. Rust/scale is prevalent on decks and bulkheads.

**Prepare, prime and paint space.**

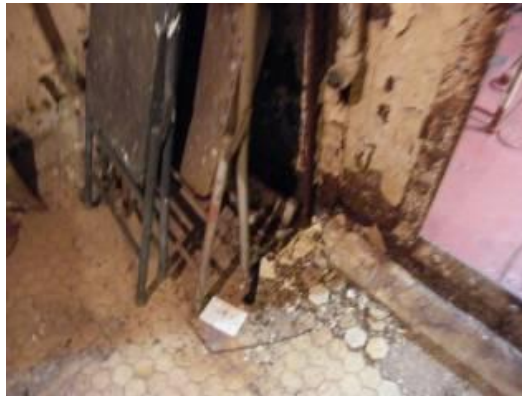
**Figure 164 Decontamination Station No. 1**

This space (Figure 164) is in poor material and cosmetic condition. The tiled deck is failing, indicating severe rust/scale and possible failure below. There is failed paint system throughout.

**Consider pulling up failed tile system and renew steel deck as needed.**

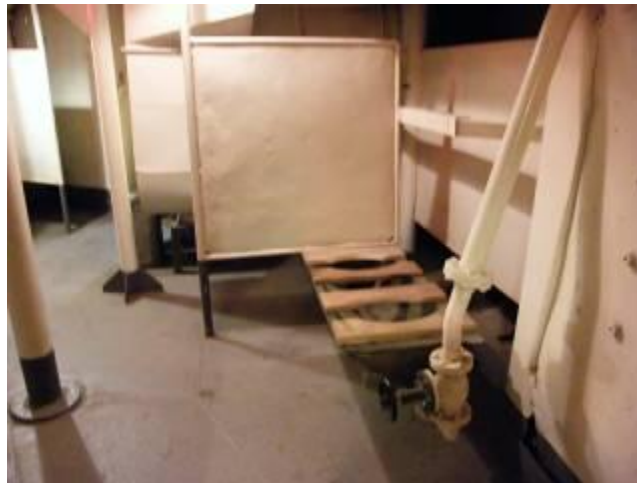
**Figure 170 W. C. Head**

This space (Figure 170) is in original condition and is not opened on a regular basis. Rust/scale is prevalent on decks and bulkheads.

**Prepare, prime and paint space.**

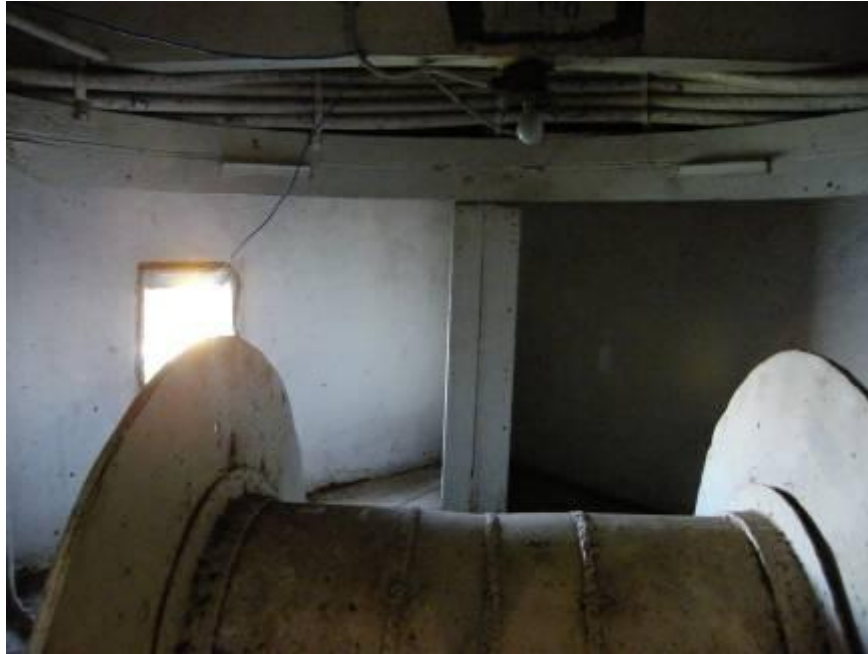
**Figure 173 Aft Stern Locker**

This space (Figure 173) is in original condition and is not opened on a regular basis. Rust/scale is

prevalent on decks and bulkheads. Steel plating has been opened up with access ports above the waterline. The access for dewatering hoses has been done on the port side aft; this can be re-plated when the lower spaces have been repaired. Steel plating has been opened up with access ports above the waterline. The access for dewatering hoses has been cut into the side shell plating on the port and starboard side aft; this can be re-plated when the lower spaces have been repaired and de-watering is not a concern.

**Replace missing plating where cuts in the hull have been made.**

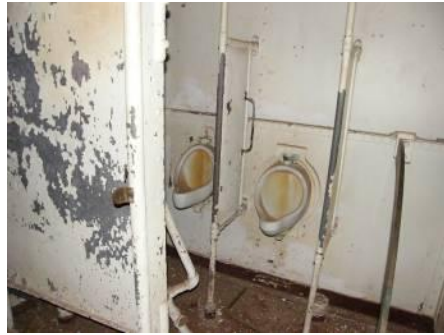
**Figure 175 W.C. Head**

This space (Figure 175) is in good structural and poor cosmetic condition with much of the original piping missing. Rust/scale abounds with a failed paint system.

<b>Prepare, prime and paint space.</b>
--

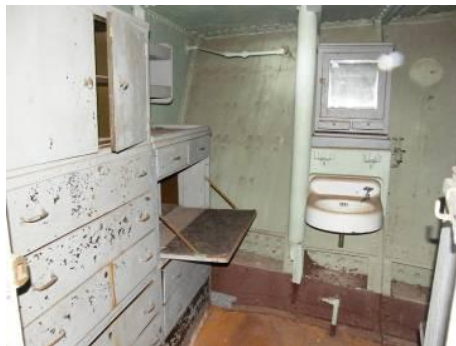
**Figure 176 Stateroom "16" (Port)**

This space (Figure 176) is in good structural and poor cosmetic condition. Rust/scale abounds with a failed paint system.

<b>Prepare, prime and paint space.</b>
--

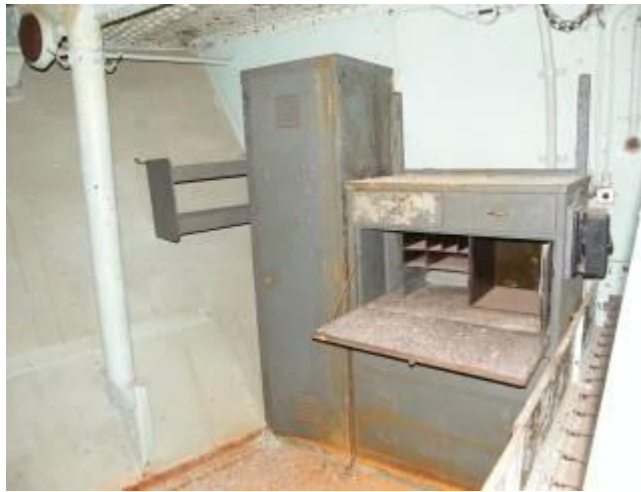
**Figure 177 Stateroom "14" (Port)**

This space (Figure 177) is in good structural and poor cosmetic condition. Rust/scale abounds with a failed paint system.

**Prepare, prime and paint space.**

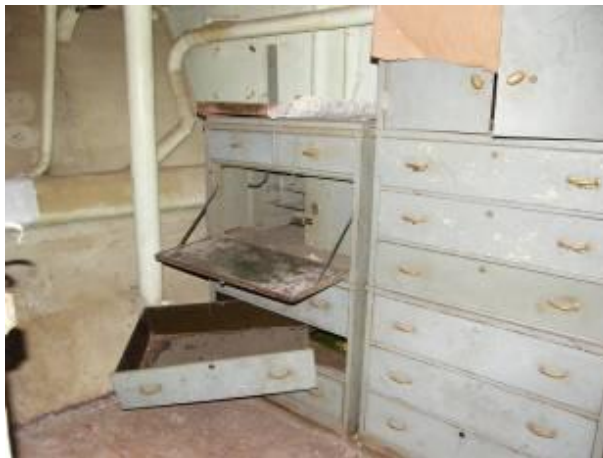
**Figure 178 Stateroom "12" (Port)**

This space (Figure 178) is in good structural and poor cosmetic condition. Rust/scale abounds with a failed paint system.

**Prepare, prime and paint space.**

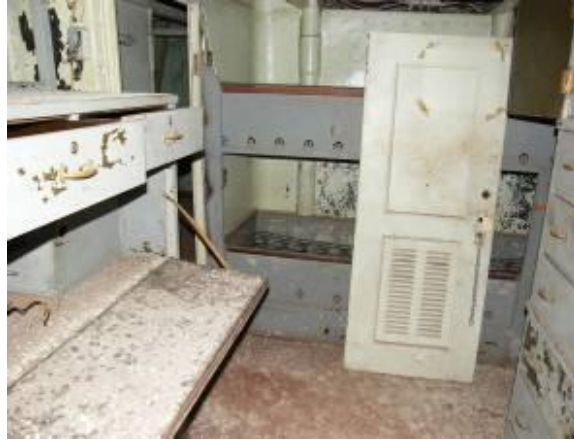
**Figure 179 Stateroom "10" (Port)**

This space (Figure 179) is in good structural and poor cosmetic condition. The lightly built steel separator bulkhead is buckled, but is not an indicator of any immediate structural concern. The vertical stanchions supporting the overhead are in good repair. There is much rust/scale with a failed paint system.

**Prepare, prime and paint space.**

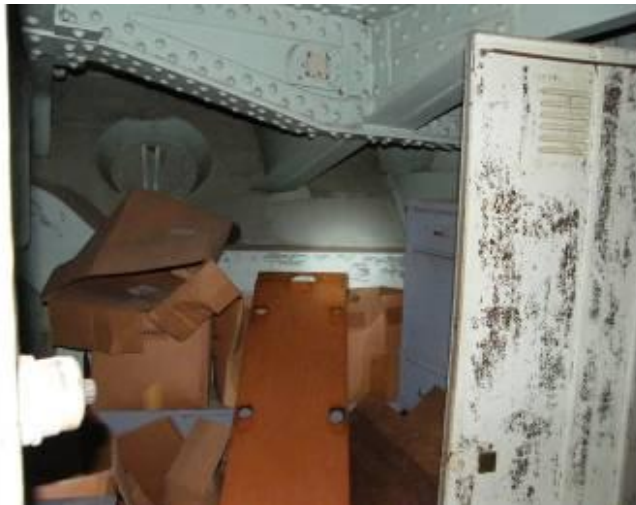
**Figure 180 Stateroom "8" (Port)**

This space (Figure 180) is in good structural and poor cosmetic condition. The lightly built steel separator bulkhead has buckled, but is not an indicator of immediate structural concern. The vertical stanchions supporting overhead are in good repair. There is much rust/scale with a failed paint system.

**Prepare, prime and paint space.**

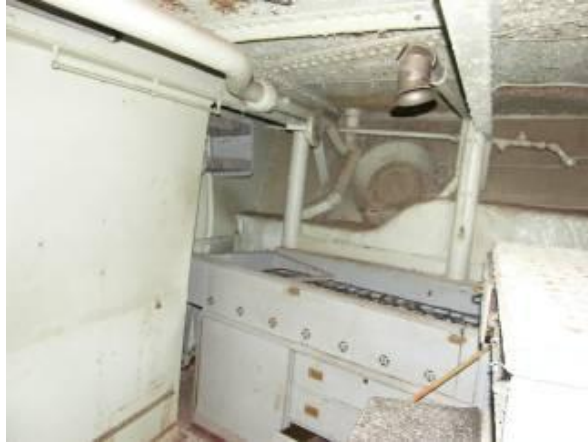
**Figure 181 Stateroom “6” (Port)**

This space (Figure 181) is in good structural and poor cosmetic condition. Rust/scale abounds with a failed paint system.

**Prepare, prime and paint space.**

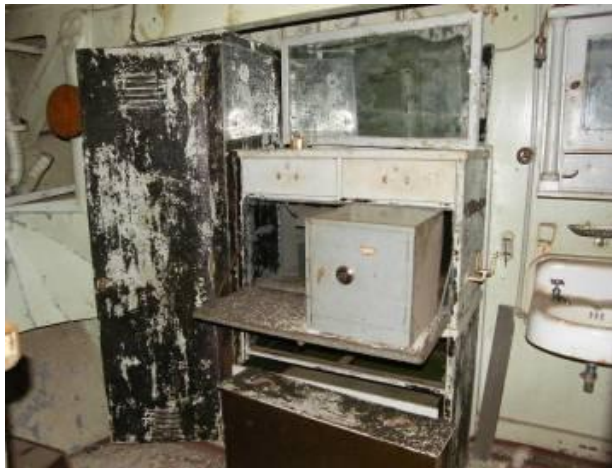
**Figure 182 Stateroom “4” (Port)**

This space (Figure 182) is in good structural and poor cosmetic condition. Rust/scale abounds with a failed paint system.

**Prepare, prime and paint space.**

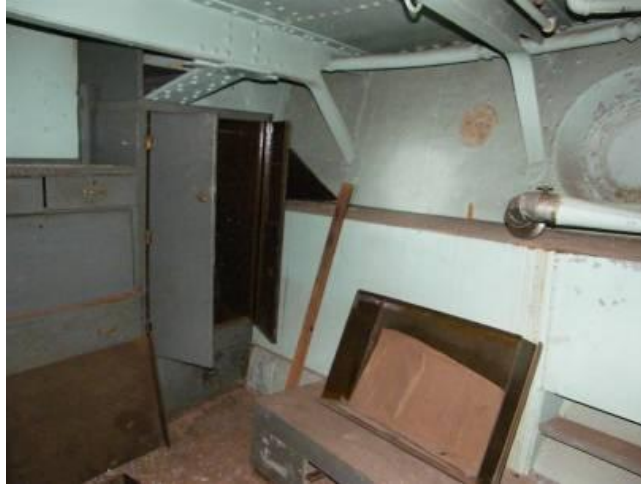
**Figure 183 Stateroom “2” (Port)**

This space (Figure 183) is in good structural and poor cosmetic condition. Rust/scale abounds with a failed paint system.

**Prepare, prime and paint space.**

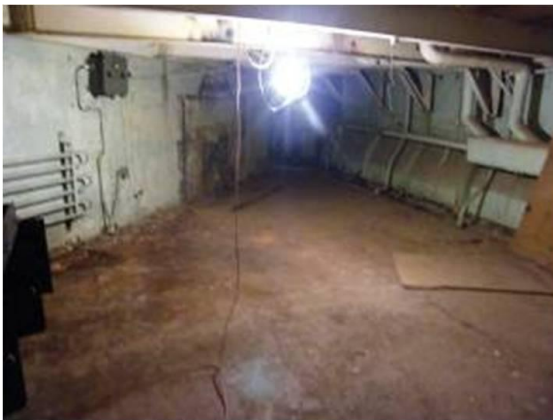
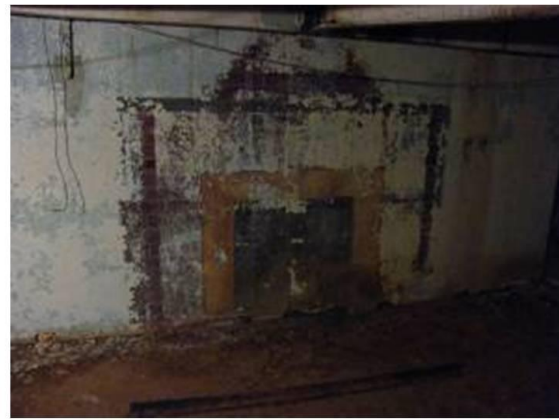
**Figure 184 Warrant Officer’s Mess (Port)**

This space (Figure 184) is in fair/good structural and poor cosmetic condition. There is much rust/scale with a failed paint system. There is heavy rust/scale at the base of the inboard bulkhead. The simulated fireplace is of historical import.

**Prepare, prime and paint space.**

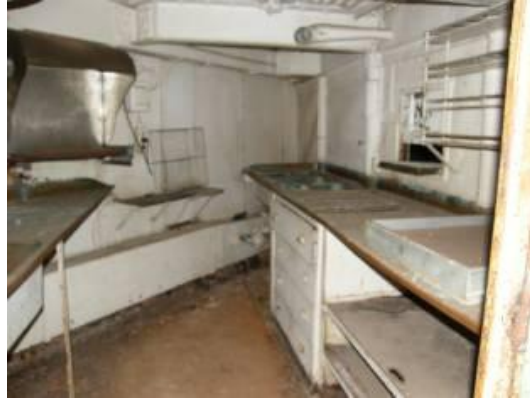
**Figure 185 Warrant Officer's Pantry (Port)**

This space (Figure 185) is in good structural and poor cosmetic condition. Rust/scale abounds with a failed paint system.

**Prepare, prime and paint space.**

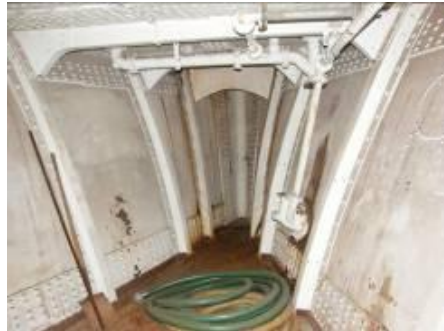
**Figure 186 Forward Stateroom (Starboard)**

This space (Figure 186) is in good structural and poor/fair cosmetic condition. Rust/scale abounds with a failed paint system and there have been leaks from the second deck.

**Seal overhead leaks.**

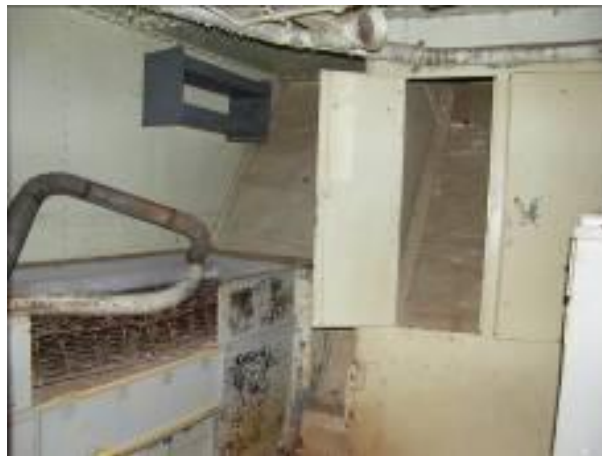
**Figure 188 Stateroom "23" (Starboard)**

This space (Figure 188) is in good structural and poor/fair cosmetic condition. Rust/scale abounds with a failed paint system and there have been leaks from the second deck.

<p><b>Seal overhead leaks.</b></p>
------------------------------------

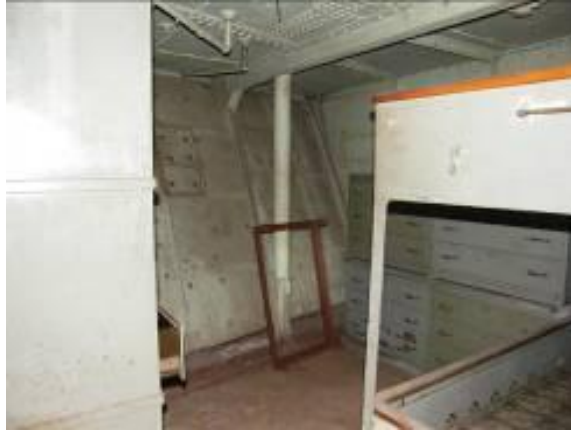
**Figure 189 Stateroom “19” (Starboard)**

This space (Figure 189) is in good structural and poor/fair cosmetic condition. Vertical stanchions supporting overhead in good repair. Rust/scale abounds with a failed paint system.

**Prepare, prime and paint space.**

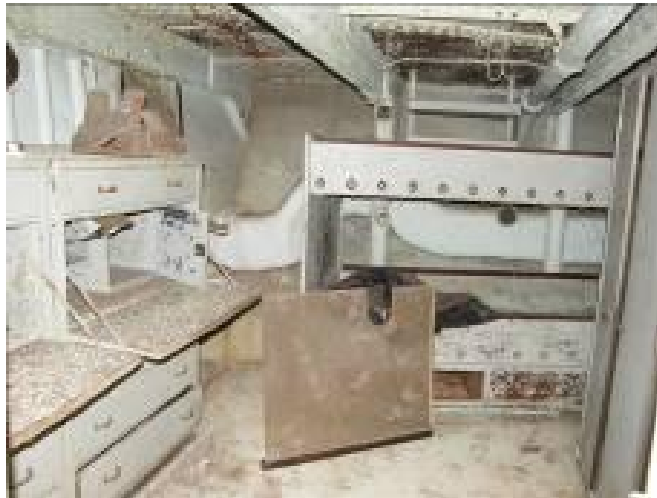
**Figure 190 Stateroom “13” (Starboard)**

This space (Figure 190) is in good structural and poor/fair cosmetic condition. The lightly built steel separator bulkheads have buckled, but are not an indicator of immediate structural concern. The vertical stanchions supporting the overhead are in good repair. There is much rust/scale with a failed paint system.

**Prepare, prime and paint space.**

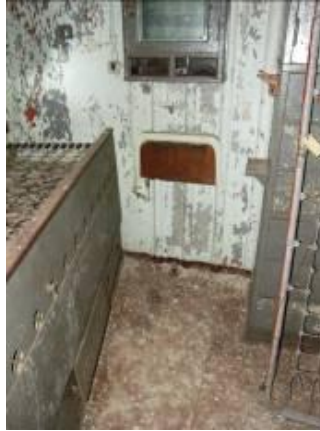
**Figure 191 Stateroom “11” (Starboard)**

This (Figure 191) space is in good structural and poor/fair cosmetic condition. The lightly built steel separator bulkhead has buckled, but is not an indicator of structural concern. The vertical stanchions supporting the overhead are in good repair. There is much rust/scale with a failed paint system.

**Prepare, prime and paint space.**

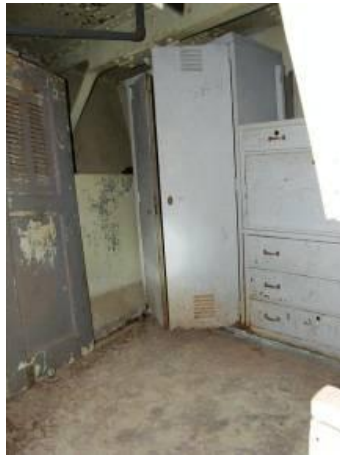
**Figure 192 Stateroom “9” (Starboard)**

This space (Figure 192) is in good structural and poor/fair cosmetic condition. The lightly built steel separator bulkhead has buckled, but is not an indicator of immediate structural concern. The vertical stanchions supporting the overhead are in good repair. There is much rust/scale with a failed paint system.

**Prepare, prime and paint space.**

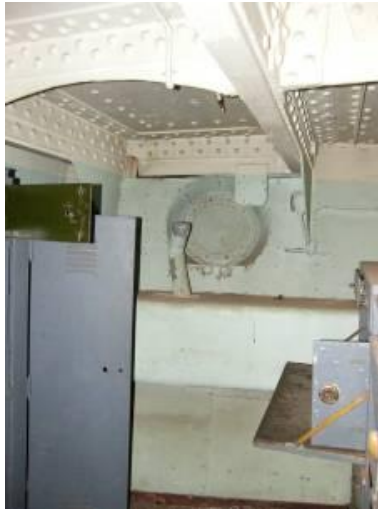
**Figure 193 Stateroom “7” (Starboard)**

This space (Figure 193) is in good structural and poor/fair cosmetic condition. Rust/scale abounds with a failed paint system. The lightly built steel separator bulkhead has buckled, but is not an indicator of immediate structural concern. The vertical stanchions supporting the overhead are in good repair.

**Prepare, prime and paint space.**

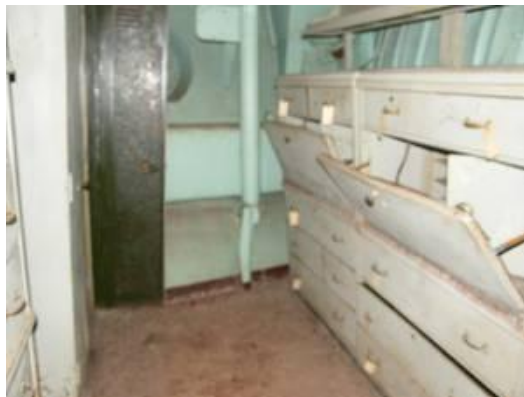
**Figure 194 Stateroom “5” (Starboard)**

This space (Figure 194) is in good structural and poor/fair cosmetic condition. The lightly built steel separator bulkhead has buckled, but is not an indicator of immediate structural concern. The vertical stanchions supporting the overhead are in good repair. There is much rust/scale with a failed paint system.

**Prepare, prime and paint space.**

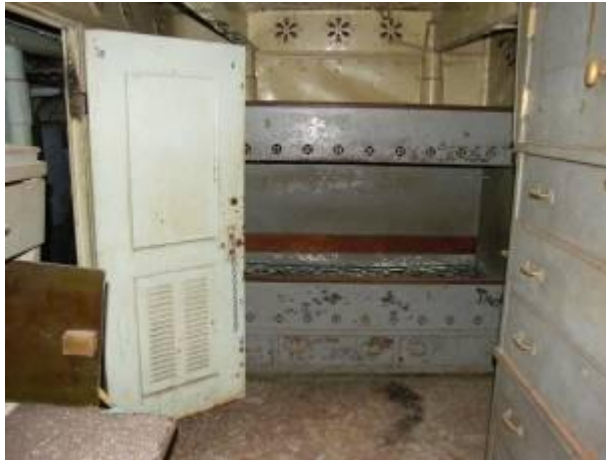
**Figure 195 Stateroom “3” (Starboard)**

This space is in good structural and poor/fair cosmetic condition. The lightly built steel separator bulkhead has buckled, but is not an indicator of immediate structural concern. The vertical stanchions supporting the overhead are in good repair. There is much rust/scale with a failed paint system.

**Prepare, prime and paint space.**

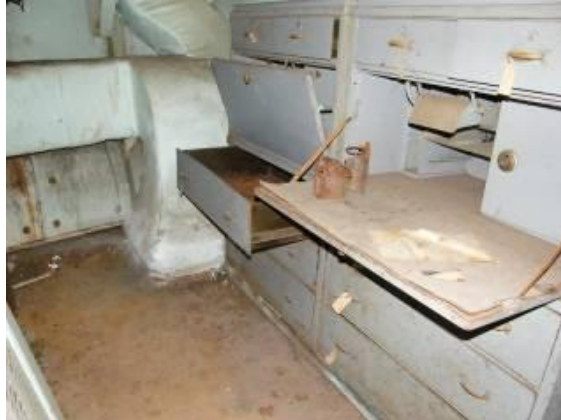
**Figure 196 Stateroom “1” (Starboard)**

This space (Figure 196) is in good structural and poor/fair cosmetic condition. The lightly built steel separator bulkhead has buckled, but is not an indicator of immediate structural concern. There is much rust/scale with a failed paint system.

**Prepare, prime and paint space.**

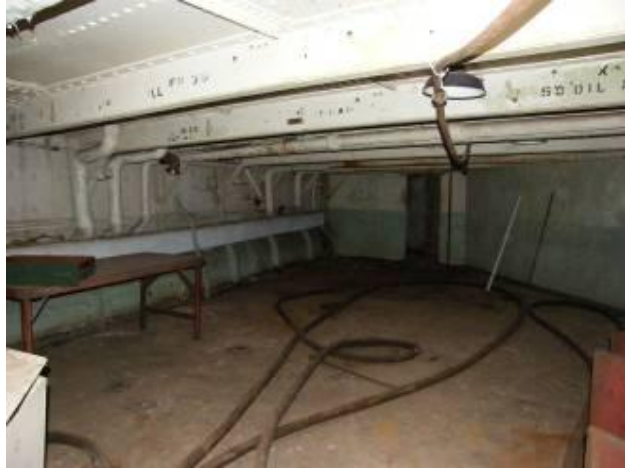
**Figure 197 Junior Officer Mess (Starboard)**

This space (Figure 197) is in good structural and poor/fair cosmetic condition. Rust/scale abounds with a failed paint system.

**Prepare, prime and paint space.**

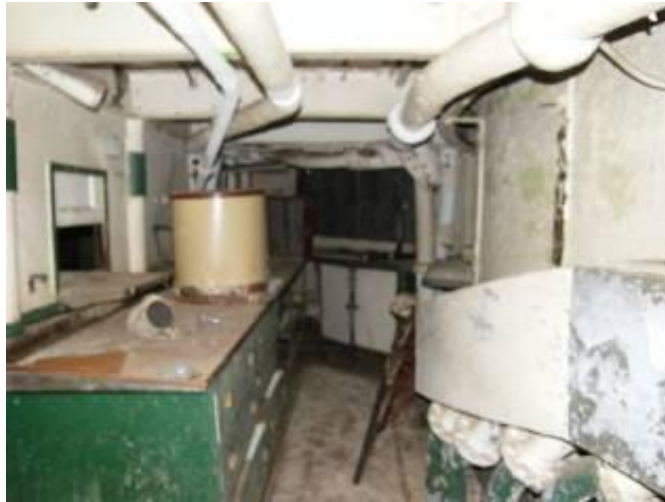
**Figure 198 Junior Officer's Pantry (Starboard)**

This space is in good structural and poor/fair cosmetic condition. Rust/scale abounds with a failed paint system.

**Prepare, prime and paint space.**

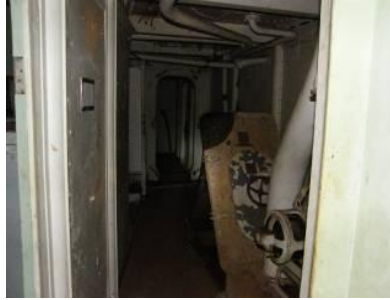
**Figure 199 Passageway (A-121; Starboard)**

This space is in good structural and poor/fair cosmetic condition. Rust/scale abounds with a failed paint system.

**Prepare, prime and paint space.**

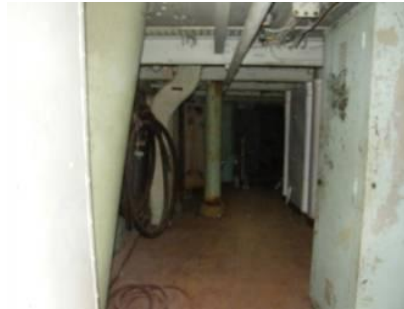
**Figure 200 Passageway (A-122; Starboard)**

This space (Figure 200) is in good structural and poor/fair cosmetic condition. Rust/scale abounds with a failed paint system.

**Prepare, prime and paint space.**

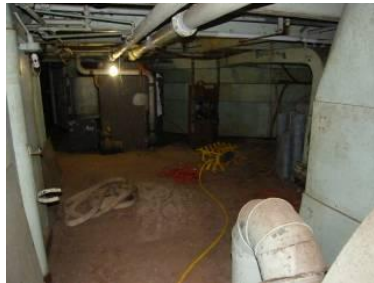
**Figure 201 Passageway (A-123; Starboard)**

This space is in good structural and poor/fair cosmetic condition. Rust/scale abounds with a failed paint system.

**Prepare, prime and paint space.**

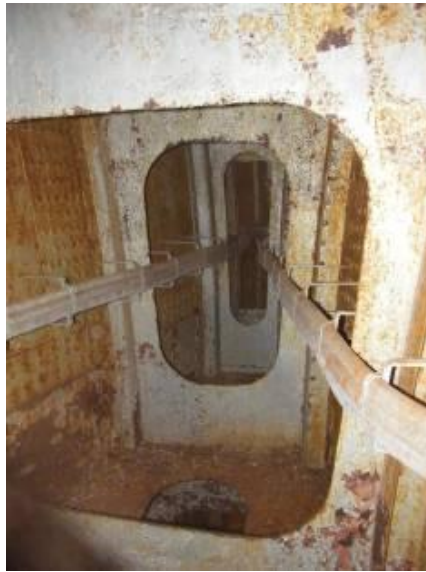
**Figure 203 Cofferdam (Stem to Frame No. 5)**

This space is in good structural and poor/fair cosmetic condition. Rust/scale abounds with a failed paint system.

<p><b>Prepare, prime and paint space.</b></p>
---

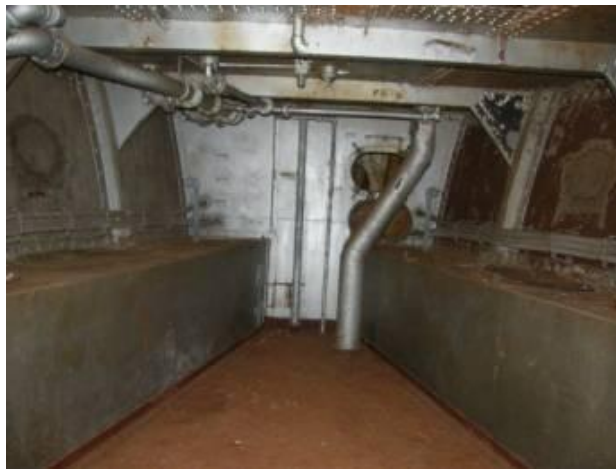
**Figure 204 Locker Room (Frames No. 5 – 9)**

This space is in good structural and poor/fair cosmetic condition. Rust/scale abounds with a failed paint system.

<p><b>Prepare, prime and paint space.</b></p>
---

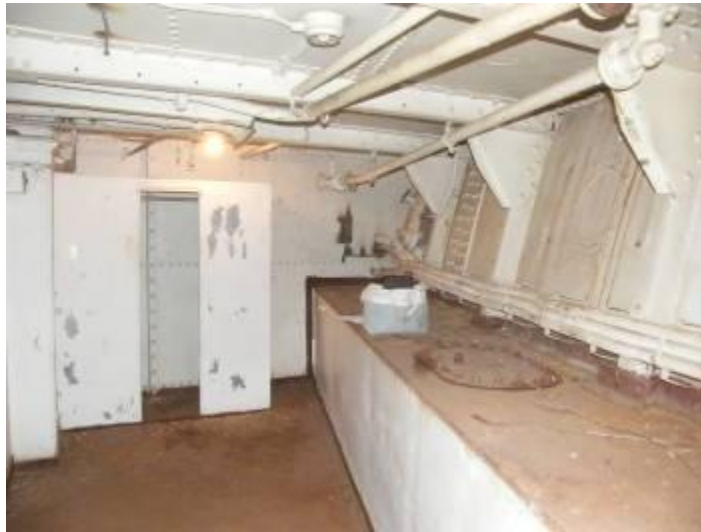
**Figure 205 Storageroom (Frames No. 9 – 14)**

This space is in good structural and poor/fair cosmetic condition. Rust/scale abounds with a failed paint system.

**Prepare, prime and paint space.**

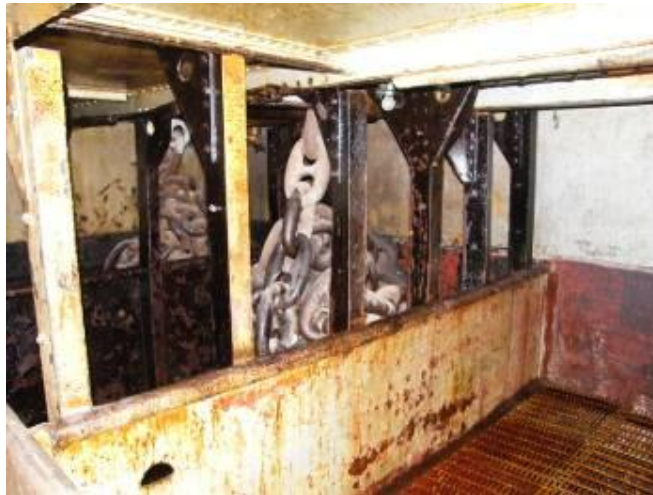
**Figure 206 Anchor Chain Locker (A-45; Frames No. 14 – 18)**

Both lockers have chain with rust/scale, standing dirt present. This space is in good structural and poor/fair cosmetic condition. Rust/scale abounds with a failed paint system.

**Prepare, prime and paint space.**

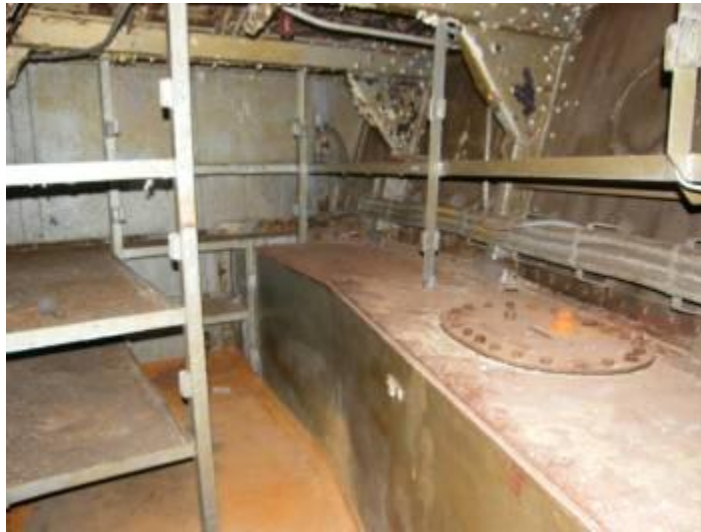
**Figure 207 Storeroom (A-103; Port)**

This space is in good structural and poor/fair cosmetic condition. Rust/scale abounds with a failed paint system.

**Prepare, prime and paint space.**

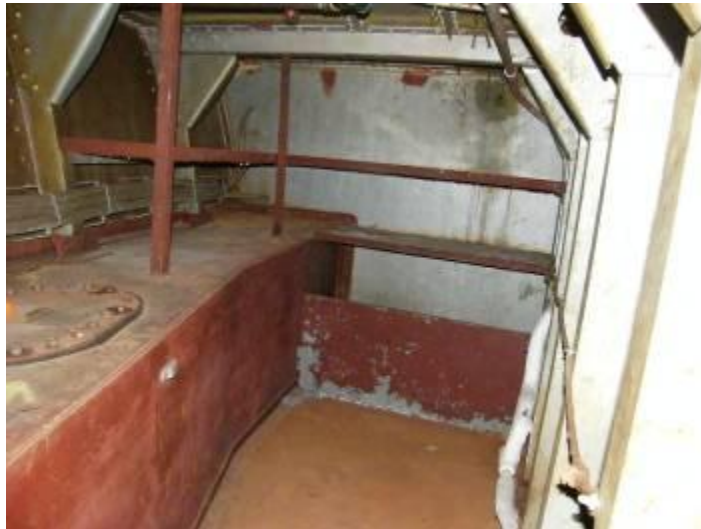
**Figure 208 Storeroom (A-104; Starboard)**

This space is in good structural and poor/fair cosmetic condition. Rust/scale abounds with a failed paint system.

**Prepare, prime and paint space.**

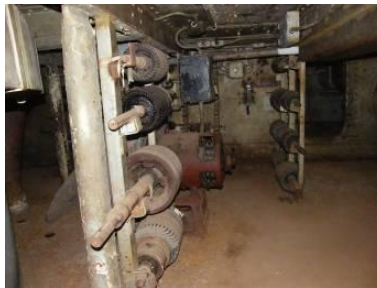
**Figure 209 Blower Space (A-111)**

This space is in good structural and poor/fair cosmetic condition. Rust/scale abounds with a failed paint system.

**Prepare, prime and paint space.**

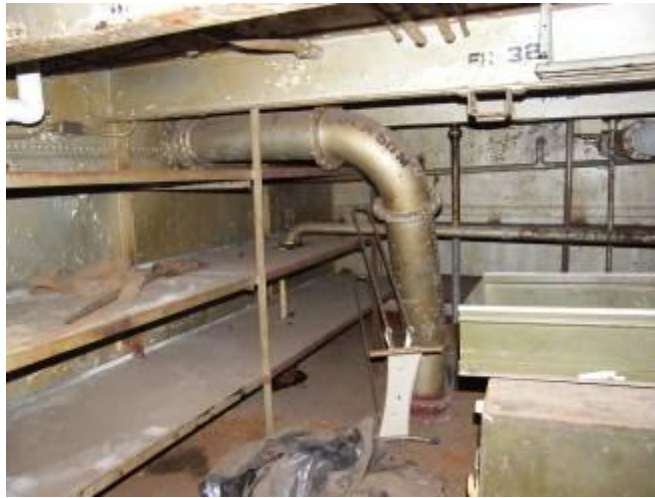
**Figure 210 Officer's Trunkroom (A-113; Starboard)**

This space is in good structural and poor/fair cosmetic condition. Rust/scale abounds with a failed paint system.

**Prepare, prime and paint space.**

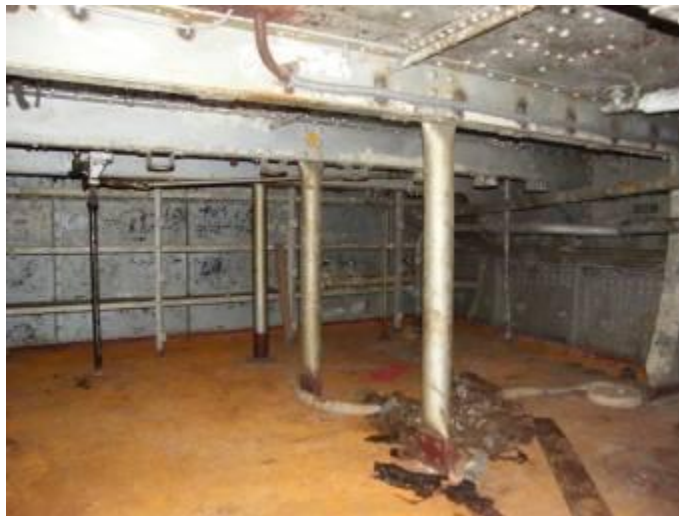
**Figure 211 Officer's Trunkroom (A-114; Port)**

These spaces are in good structural and poor/fair cosmetic condition. Rust/scale abounds with a failed paint system.

**Prepare, prime and paint space.**

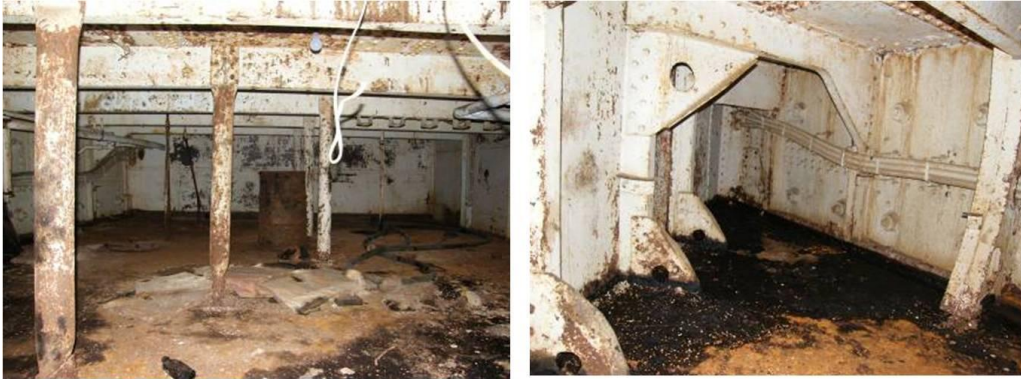
**Figure 213 Lumber Issuing Room (A-116; Port)**

This space is in good structural and poor/fair cosmetic condition. Previously flooded with oil on deck, this has largely dried, but should be cleaned. Rust/scale abounds with a failed paint system.

**Remove standing oil from space.**

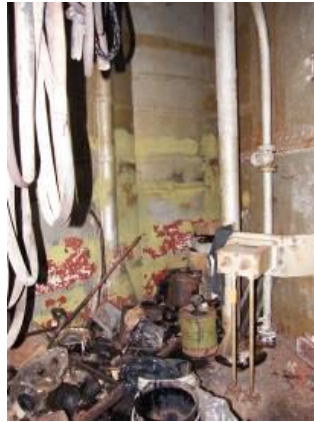
**Figure 214 DC Locker (Port)**

This space is in good structural and fair cosmetic condition. Rust/scale abounds with a failed paint system.

**Prepare, prime and paint space.**

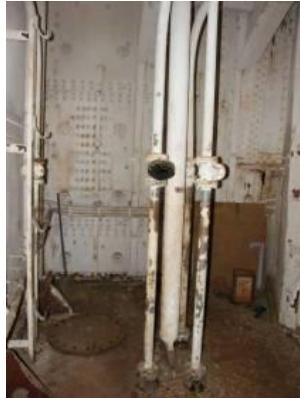
**Figure 215 Shipfitter Room (Port)**

This space is in good structural and poor/fair cosmetic condition. Rust/scale abounds with a failed paint system.

**Prepare, prime and paint space.**

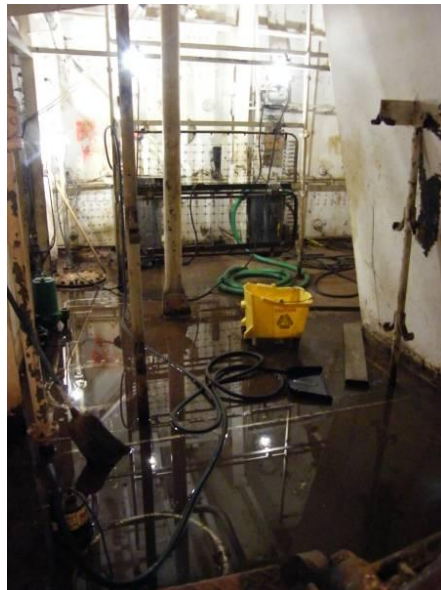
**Figure 216 Crew Space (B-104; Frames No. 50-58; Port)**

This space is in good structural and poor/fair cosmetic condition. Presently flooded with water and oil on deck; should be cleaned. Rust/scale abounds with a failed paint system.

**Remove standing oil/water from space. Repair source of water.**

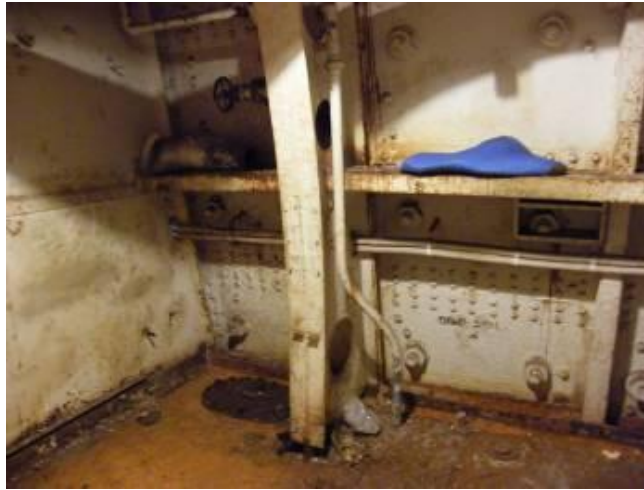
**Figure 221 Master-At-Arms Office (Port)**

This space is in good structural and poor/fair cosmetic condition. Rust/scale abounds with a failed paint system.

**Prepare, prime and paint space.**

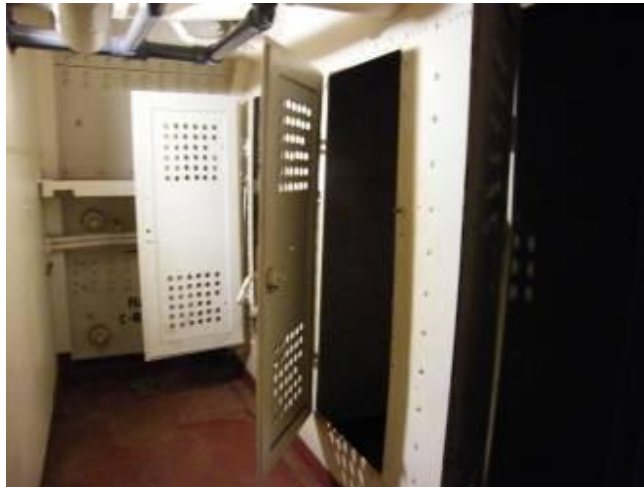
**Figure 222 Brig (Port)**

This space is in good structural and good cosmetic condition.

**Prepare, prime and paint space.**

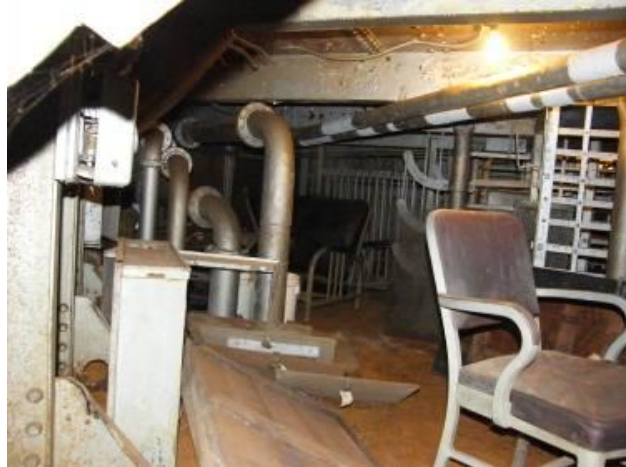
**Figure 223 Metal Issuing Room (Starboard)**

This space is in good structural and good cosmetic condition.

<b>Prepare, prime and paint space.</b>
--

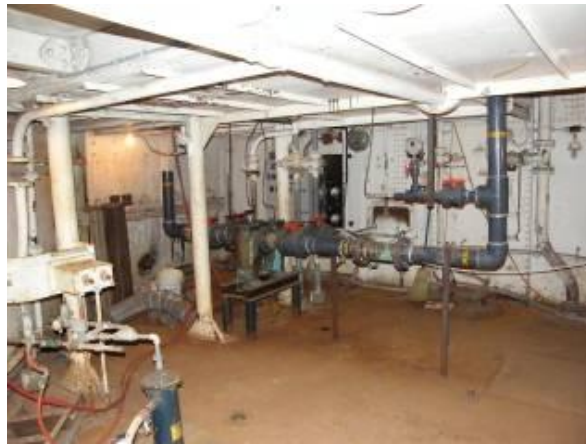
**Figure 224 Passageway (B-101; Starboard)**

This space is in good structural and good cosmetic condition.

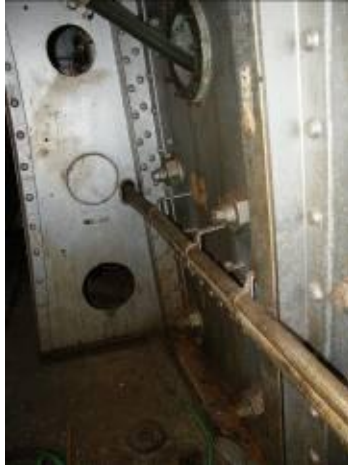
**Figure 225 Relay Room (B-103; Starboard)**

This space is in good structural and good cosmetic condition and utilized for storage.

<b>Prepare, prime and paint space.</b>
--

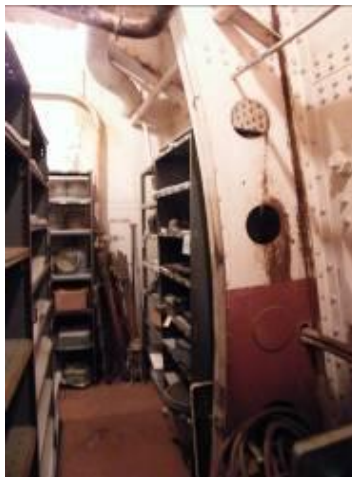
**Figure 226 Crew Space (B-105; Frames No. 54 – 58; Starboard)**

This space is in good structural and good cosmetic condition and utilized for storage.

<b>Prepare, prime and paint space.</b>
--

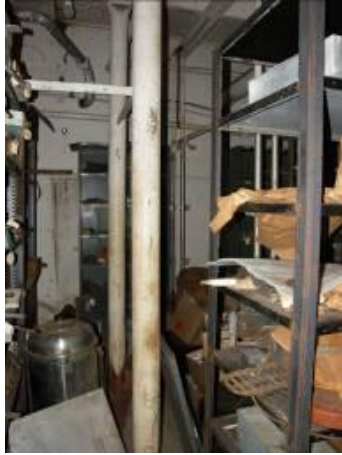
**Figure 227 Crew Space (B-107, Frames No. 58 – 66; Starboard)**

This space is in good structural and good cosmetic condition and is utilized for storage.

**Prepare, prime and paint space.**

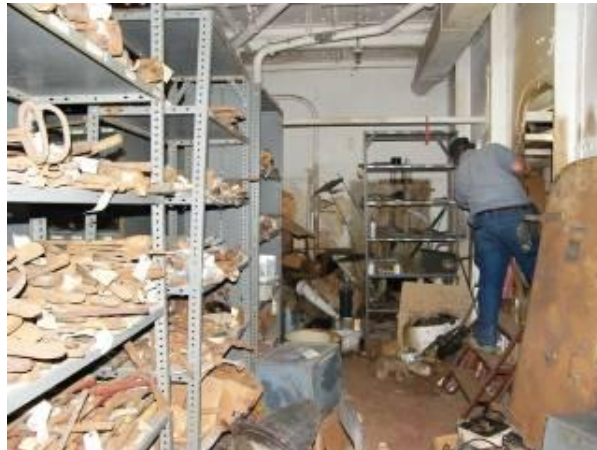
**Figure 228 Crew Space (B-111, Frames No. 66 – 76)**

This space is in good structural and good cosmetic condition and is utilized for storage.

**Prepare, prime and paint space.**

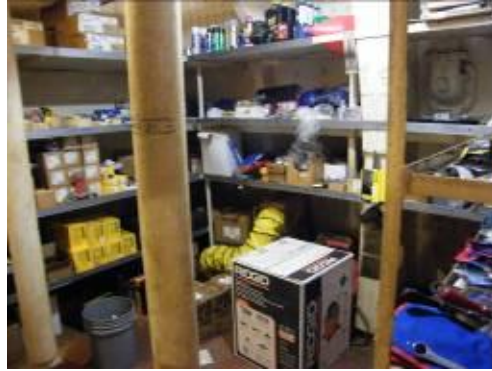
**Figure 229 Clothing and Small Stores (Starboard)**

This space is in good structural and good cosmetic condition and is utilized for storage.

<b>Prepare, prime and paint space.</b>
--

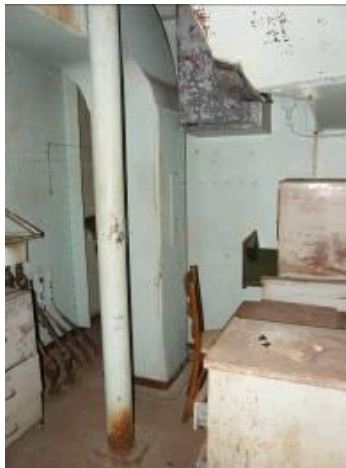
**Figure 230 Commissary Office**

This space is in good structural and good cosmetic condition and is utilized for storage.

<b>Prepare, prime and paint space.</b>
--

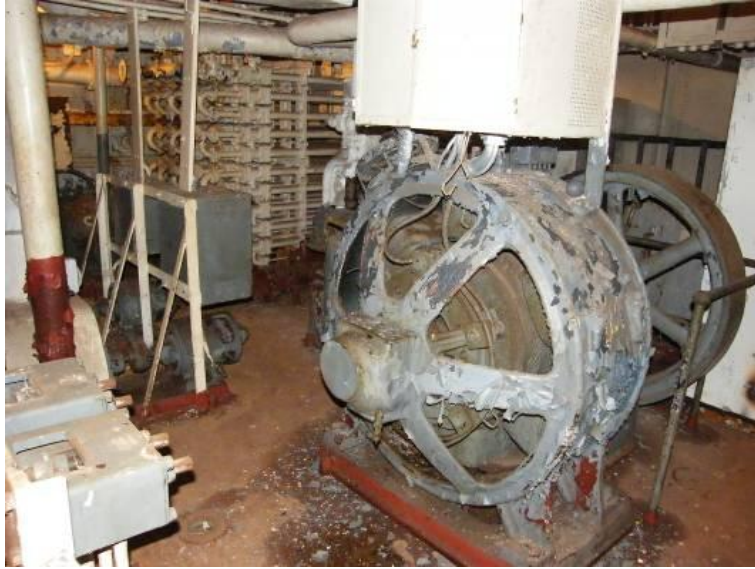
**Figure 231 Main Communication Station (A-116 ½; Centerline)**

This space is in good structural and fair cosmetic condition. The space is largely original.

**Prepare, prime and paint space.**
